PIKE COUNTY, PENNSYLVANIA
PHASE II INSPECTION REPORT
NATIONAL DAM INSPECTION PROGRAM

PHASE I REPORT
NATIONAL DAM INSPECTION PROGRAM

Name of Dam: LOWER HEMLOCK DAM
State & State No.: PENNSYLVANIA, 52-117
County: PIKE
Stream: TRIBUTARY TO ROCK HILL CREEK
Date of Inspection: April 2, 1980

LOWER HEMLOCK DAM

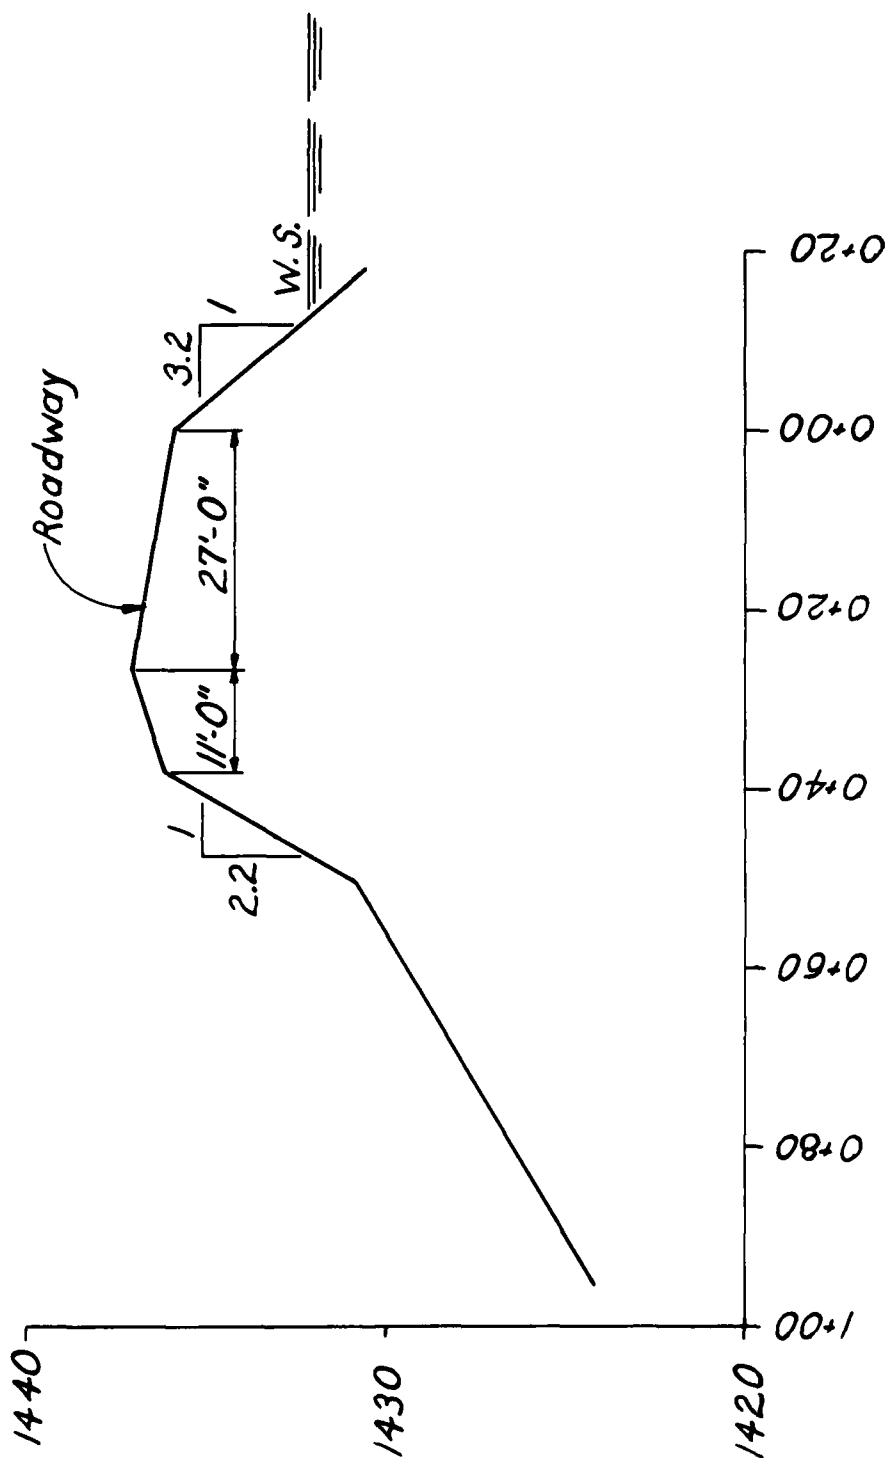
EMBANKMENT SECTION
STA. 1+40

The downstream slope is very irregular due to a natural high ridge near the center of the embankment (Plate III, Appendix E) and by the apparent placement of spoil material near the right abutment. This spoil consists of large boulders. Fine material has been washed out between these boulders creating what appears to be "sink holes." This area is downstream from the actual toe of the dam and the condition is not considered serious. A section of the downstream toe is formed by a two to three foot high loose-laid stone wall. Some seepage was noticed through this wall near the outlet pipe. Although some discoloration (reddish) was noticed in the water, the distance to the reservoir and the presence of the large rocks and stone indicates that this condition is not serious. Some trees are located in the spoil areas and above the wall.
